GUARD VESSEL INCIDENT NOTIFICATION

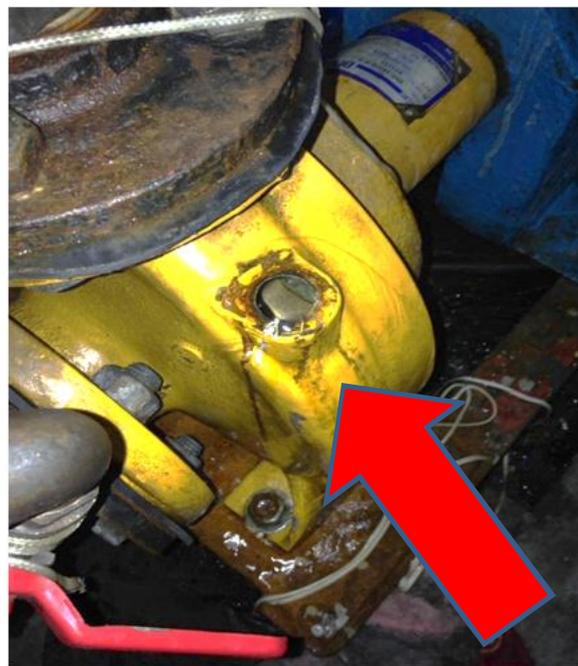
The main engine seawater cooling pump was identified as the source of the problem, where the vent pipe was no longer providing a seal and water was exiting the pump casing at this location.

The inspection showed that the internal threads of the fitting had corroded causing the failure to seal. It was decided by the skipper and engineer that a temporary fix was to be carried out allowing the vessel to restart the main engine and return to port which was only 25 miles away.

The bilge compartment was immediately pumped dry before the main engine was stopped allowing the outer seacock to be fully closed, cutting off the water supply and allowing the pump to be drained of water so a full assessment could be made.

SFFSL were informed and a nearby fishing vessel was contacted who shadowed the vessel into port as a precautionary measure. Repairs were completed in port and the vessel sailed to guard location as planned.
