GUARD VESSEL NEAR MISS NOTIFICATION

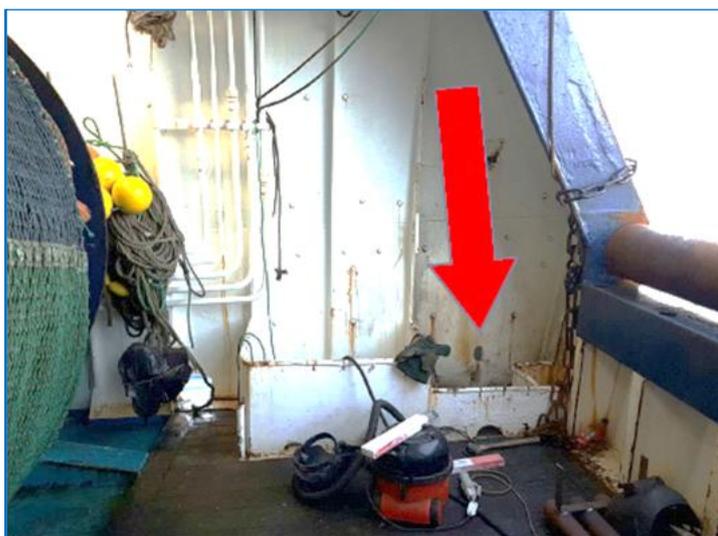
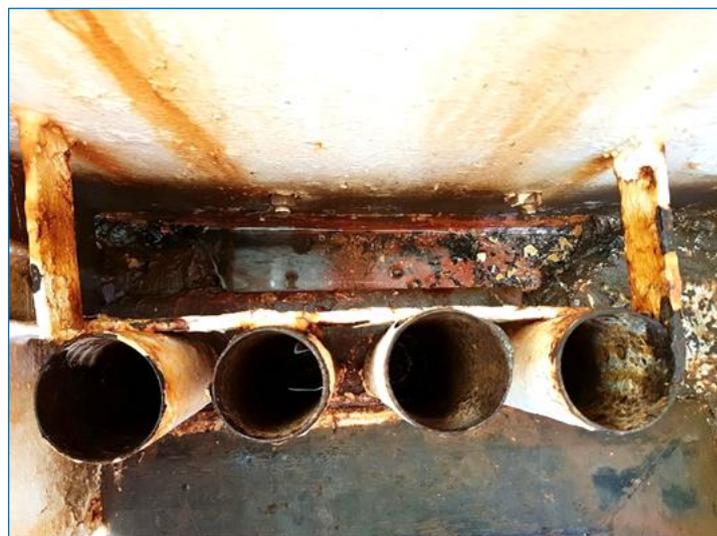
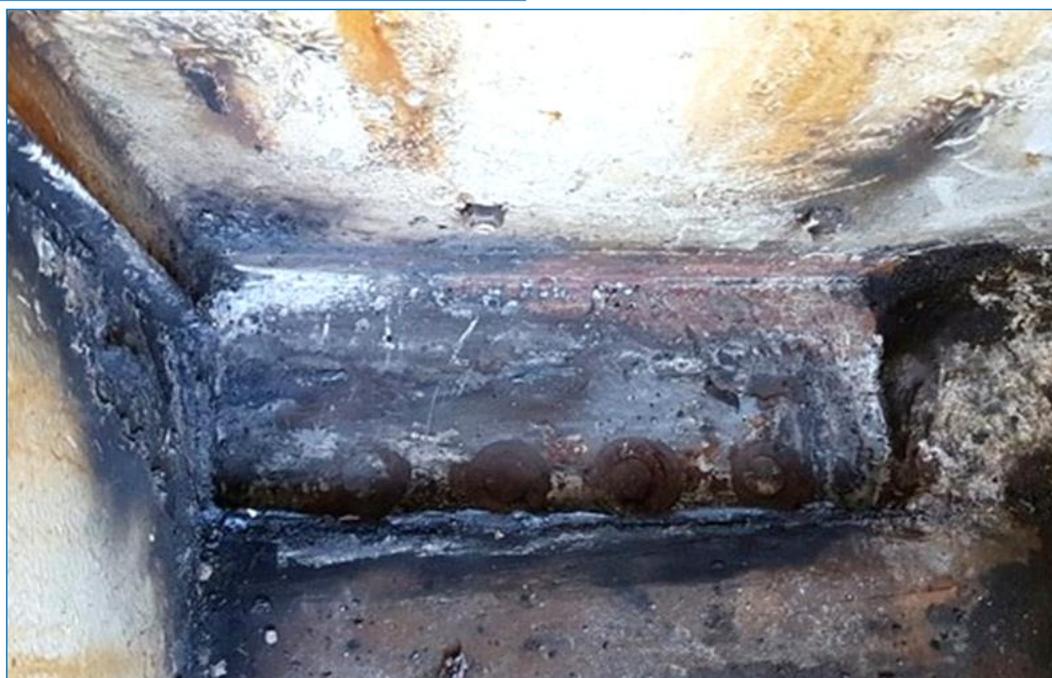
Given the vessel was only 53 miles from Lerwick, the Skipper decided to change course and enter port to allow for the matter to be fully investigated. The cause of the ingress was found to be wear to the starboard aft deck, caused by shooting poles coming into direct contact with the deck plate while in the storage position. Over the period of only a few years the two steel surfaces had rubbed together causing enough wear to allow water to pass through.

Given that the pole storage rack restricts the view preventing a visual inspection, it would have been extremely difficult to have previously identified the wear and potential ingress.

Repairs were effected immediately and the vessel was permitted to continue onto the scheduled guard trip.

- Inspecting similar storage areas on steel vessels for any wear and tear
- Installing a barrier of some kind to prevent shooting poles coming into direct contact with the steel deck

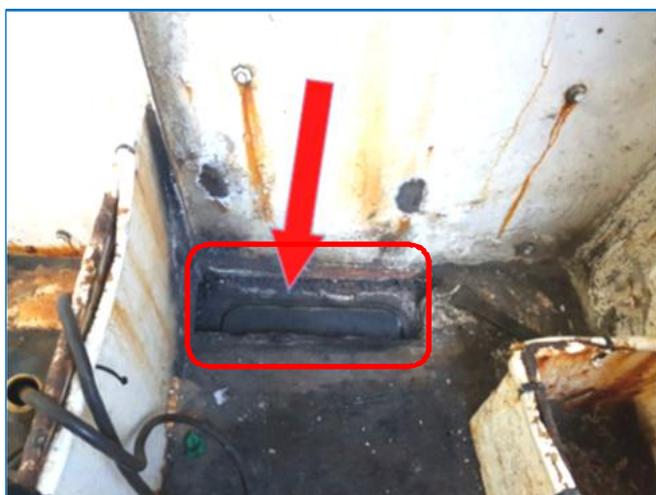
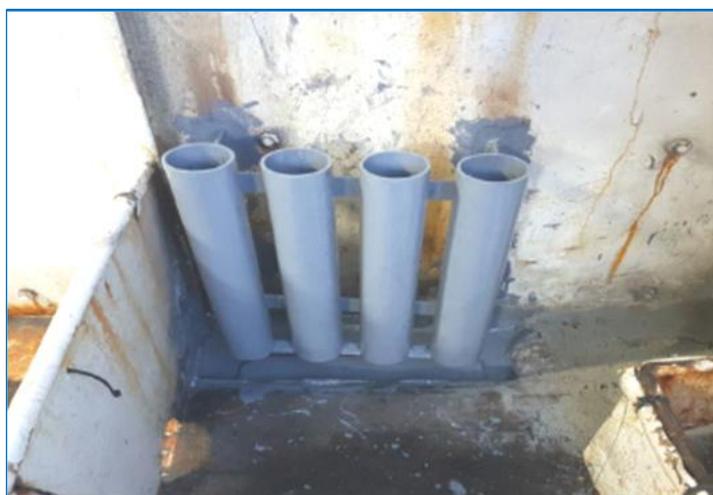
- The incident reinforced the importance of taking precautionary measures in order to avoid a potentially more serious situation developing
- The incident highlighted the potential hazard of wear between two steel surfaces
