SFF SERVICES – GUARD VESSEL INCIDENT NOTIFICATION

Discovery of a leak in steel hull

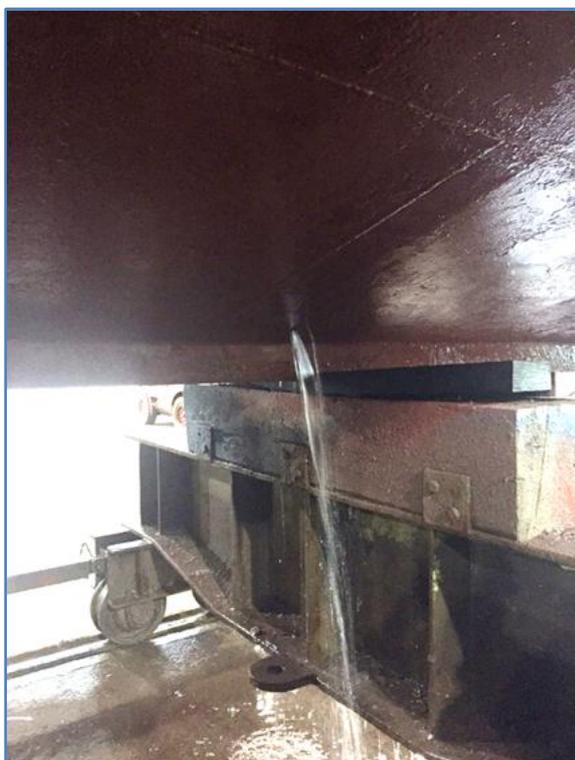
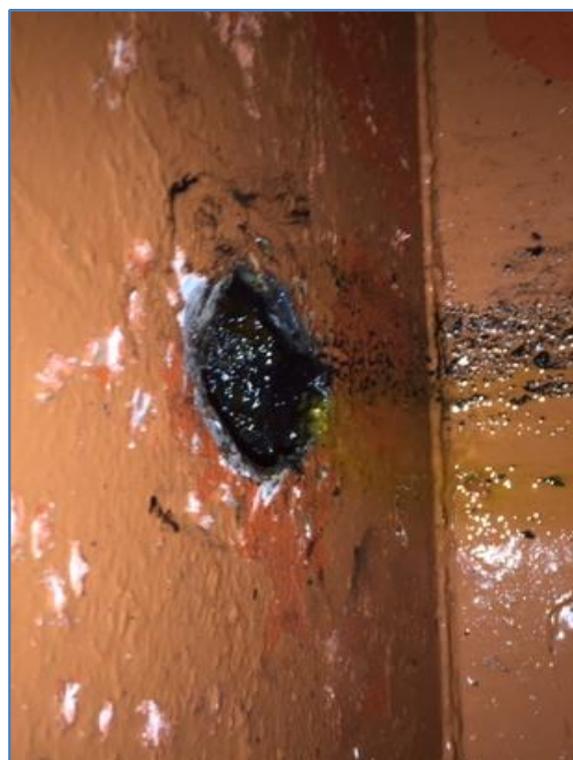
Once inspected on the ship lift, a small hole around the size of a fifty pence piece in fish room section of the hull on the starboard side was identified as the cause of the leak.

The cause of the hole was believed to be a bolt or something similar which has been moving and wearing the steel over a long period of time. It was fortunate that the vessel was heading for shelter from forecasted poor weather, meaning the vessel's proximity to a safe haven was shortened during the night.

- **weekly testing of bilge alarms** should be undertaken and recorded
- **regular visual checks of bilge wells** should be undertaken and recorded
- **the Coastguard should be contacted** in the event of any water ingress, even as a notification that the situation is under control

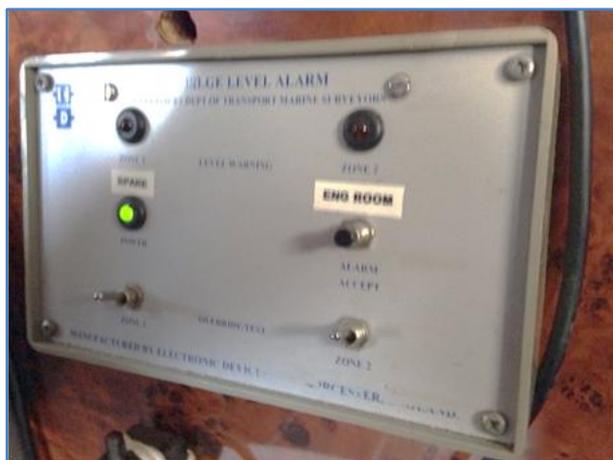
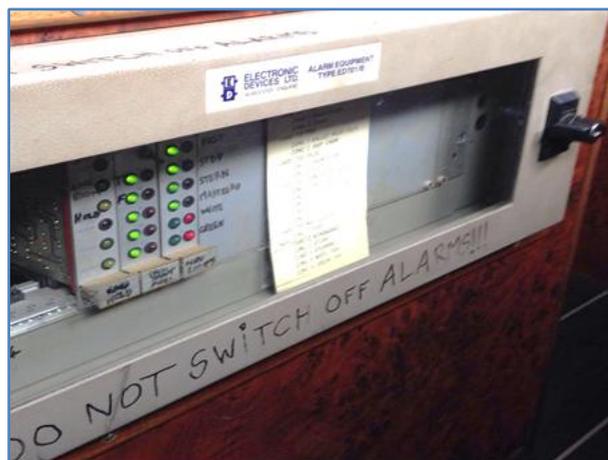
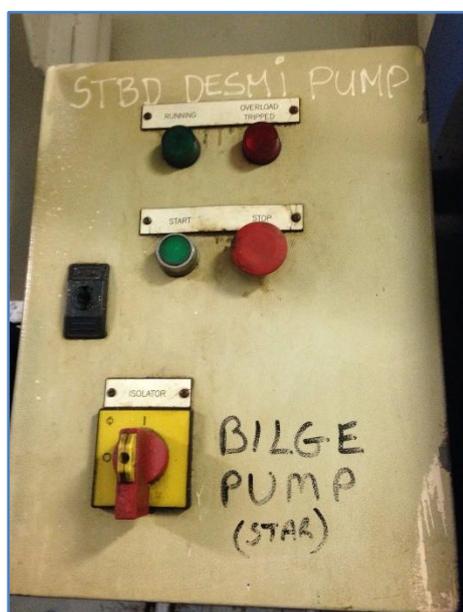
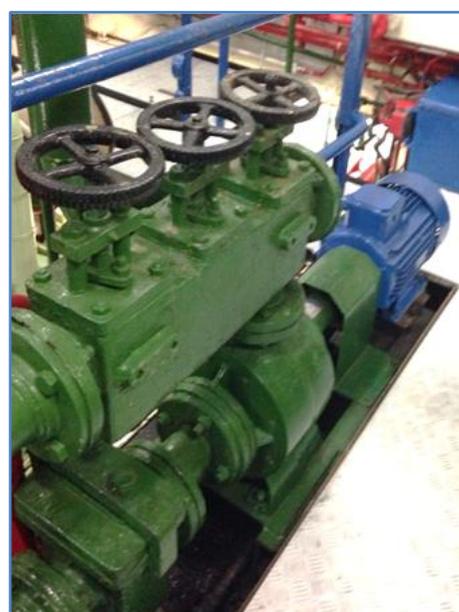
- The incident reinforced the importance of early communication of incidents to SFFSL, to allow the required reporting procedures to take place
- The Coastguard should also have been informed of incident even though it was under control, in case the situation intensified
- The incident highlighted the importance of **operational bilge alarms, well-maintained bilge pumps** and the necessity for **regular visual checks for foreign objects in all bilge compartments**
