SFF SERVICES – SAFETY FLASH

During a guard trip pre-inspection it emerged that a vessel had undergone repairs following the discovery of a small hole in the hull. **SFF Services was pleased to find that the issue had been fully investigated and repaired correctly:**

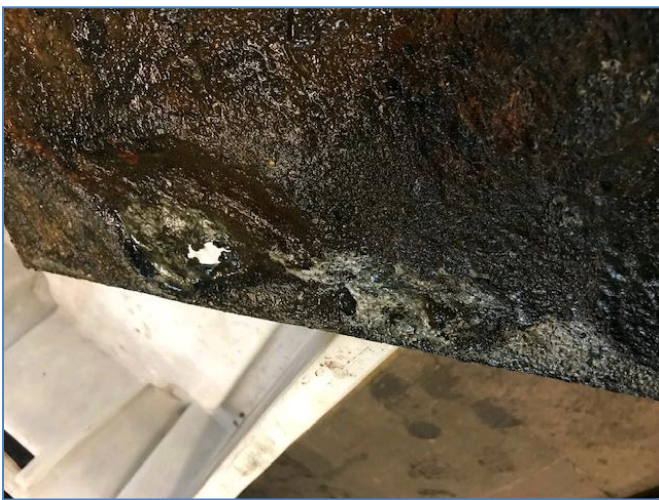
The hole was inspected on the ship lift and the corroded plate cut back to an acceptable thickness. The area was cleaned and found to be a localised problem as the surrounding areas were found to be in good condition. The small area of erosion appeared to have been caused by a piece of scrap metal lying in the bilge and wearing the hull away over time. An insert plate was fitted by MCA-approved fabricators and the vessel returned to fishing with no further issues.

Localised hole

- Any hull integrity issues should be fully investigated and repaired in compliance with MCA regulations
- Documentation confirming the extent of repairs should be requested and retained as evidence of the works
- Debris/loose items should be retrieved at the earliest opportunity and bilges inspected regularly
- Vessels will be asked to complete a normal fishing trip to confirm no issues remain before commencing guard duty

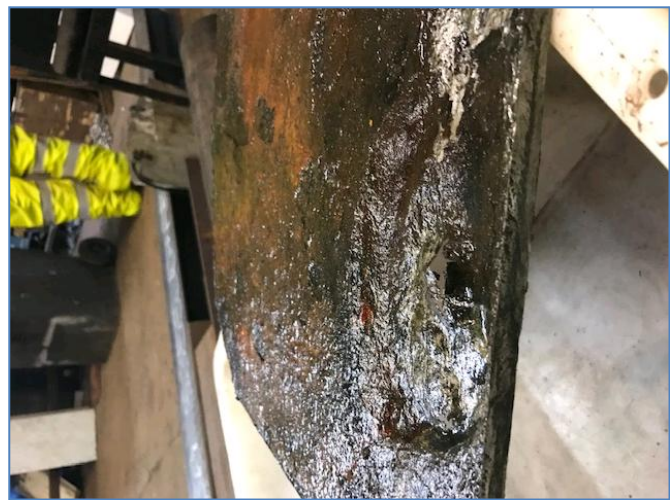
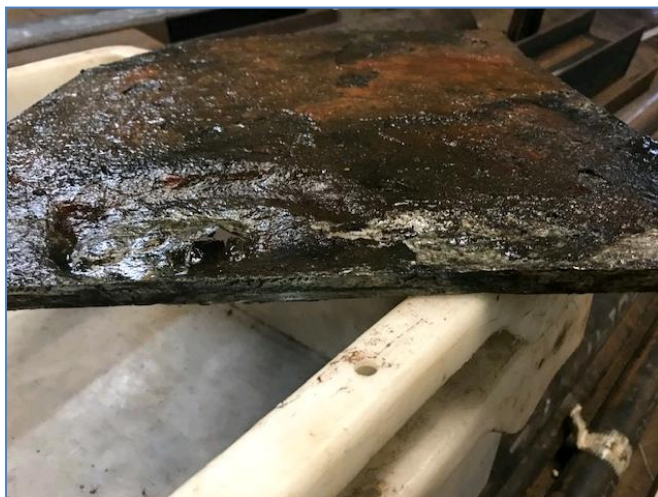
Surrounding plate thickness
