## **Note to Fishermen on The Rochelle Pipeline**

Remedial work was undertaken on specific sections (Gates) of the Rochelle pipeline in January 2013 in an effort to smooth out any potential mud mounds at these localities; the locations of the Gates are shown on the reverse of this page. Below is a brief summary of the remedial work carried out along with the overtrawlable trial findings for each location.

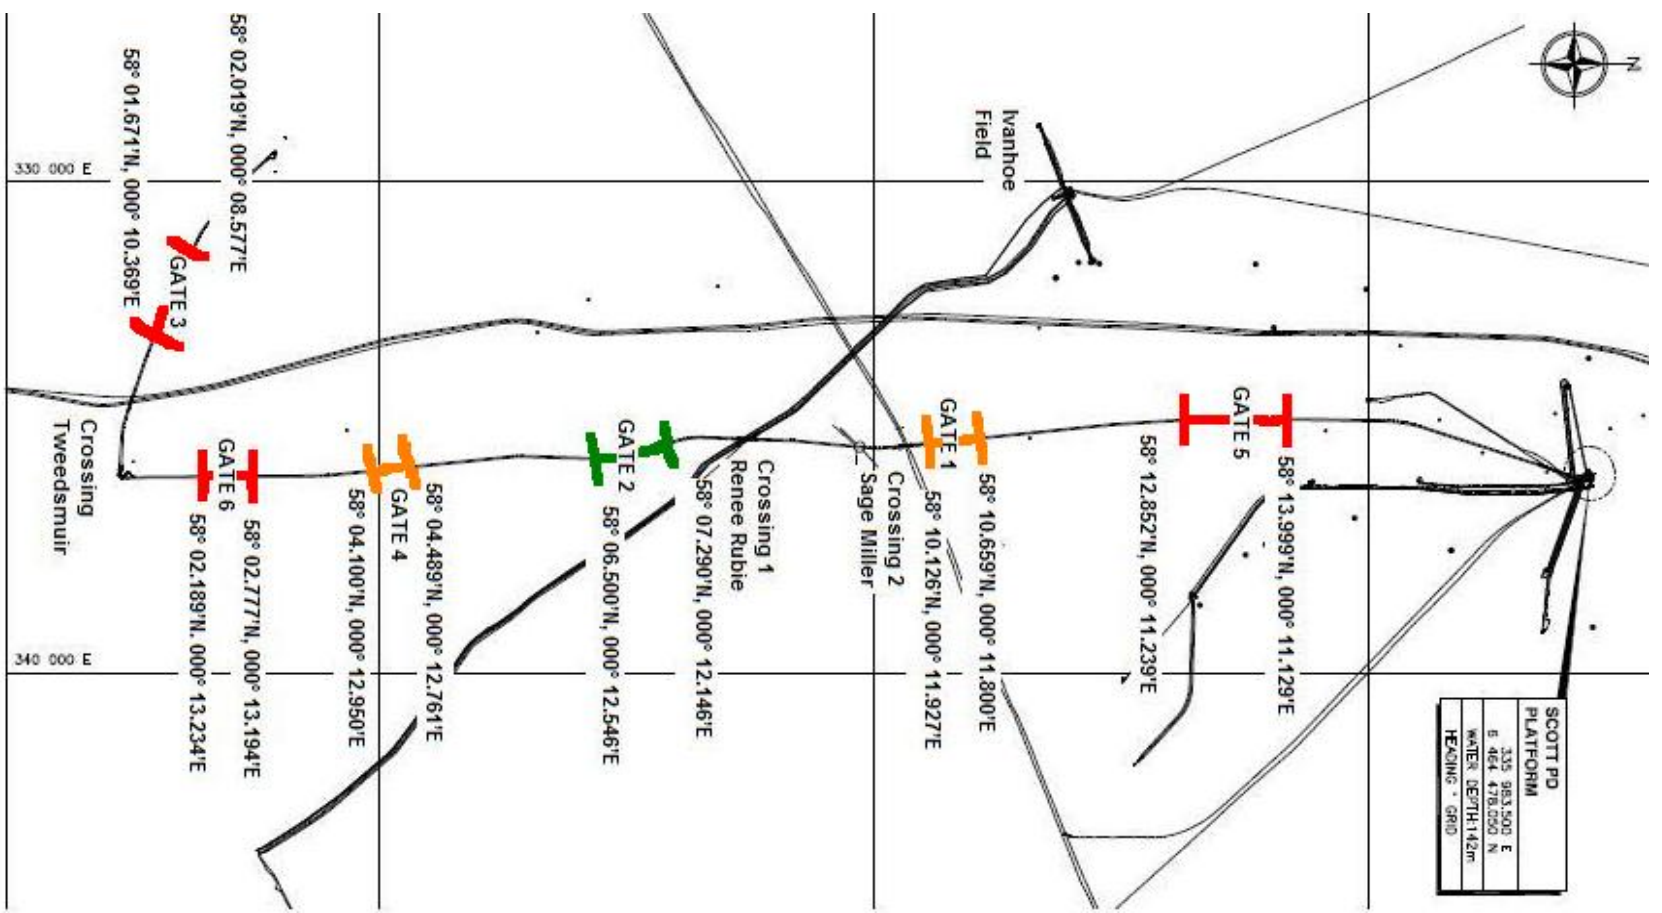
| SCOTT PD |
| PLATFORM |
| WATER DEPTH 142m |
