SFF SERVICES – GUARD VESSEL INCIDENT NOTIFICATION

Accident to a crewman while conducting routine maintenance to roller block

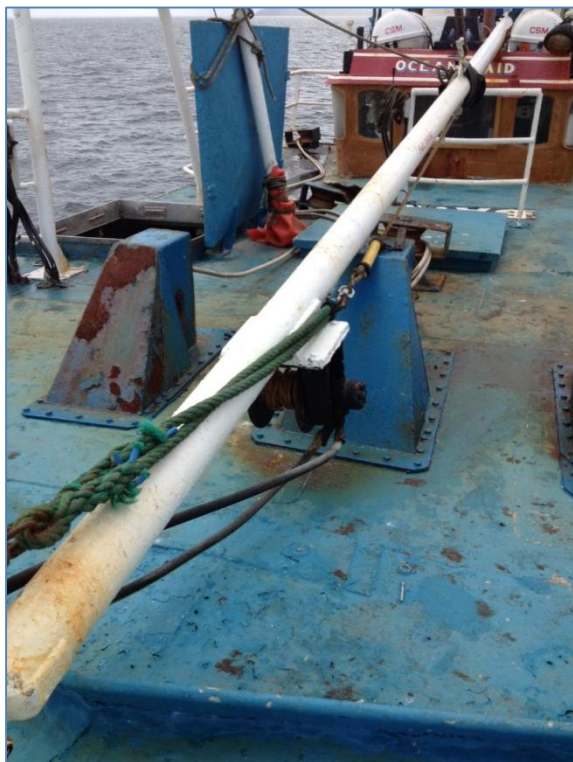
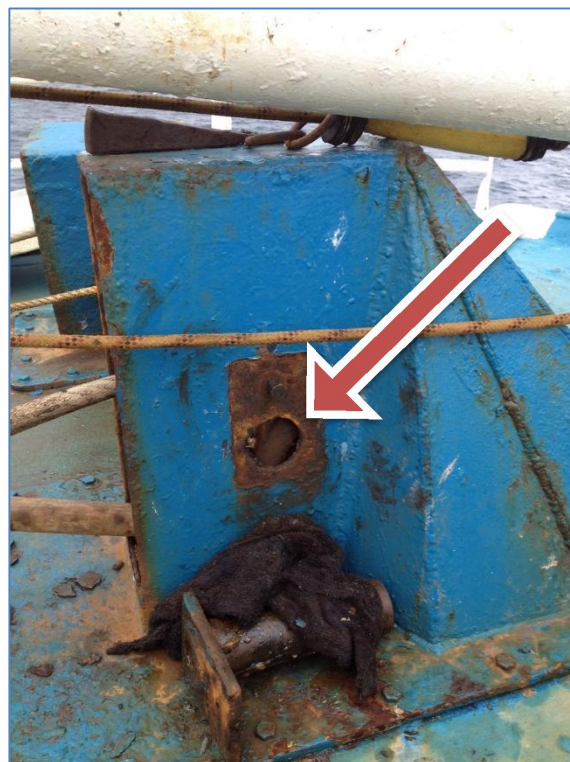
A crewman's fingertip was severed while carrying out maintenance on a top deck roller block. The centre pin had been removed to allow the sheave to be cleaned and greased. A steel bar along with steel wedges was being used to support the weight of the roller while this was carried out.

While reinserting the pin a small flake of rust was sighted causing the crewmember to place his finger in to the pin hole. An unexpected movement of the vessel caused the steel bar to slip and the heavy roller to drop. The tip of the crewman's hand was caught between the sheave and the falling roller, severing the fingertip clean off. The crewman was airlifted to hospital but the fingertip could not be reattached.

SFF Services stress to all Guard Vessels that only essential maintenance should be carried out during guard duty, and that all maintenance work on board should be risk assessed and approved by the skipper before commencement. As a control measure the vessel has acquired a tool to insert in to the pin hole during the cleaning process, this will eliminate the possibility of a similar accident happening again.
